# CAUSES & REASONS OF LAND SLIDING IN LAGA GABA HIGHLAND AREA, GIMBI TOWN, WEST WOLLEGA ZONE, ETHIOPIA

## Original Research Article

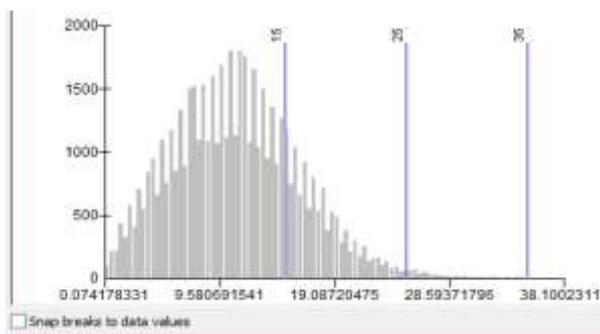
**Figure-3:** The Number of Cells Vs Slope

Relief is a principal factor in the determination of the intensity and character of landslides. It has direct as well as indirect influences. Direct influences encompass slope, steepness, river valley morphology, and thawing gradients. The most important relief characteristic is the steepness, which affects the mechanism as well as the intensity of the landslides. The greater the height, steepness and convexity of slopes, the greater the volumes of the landslides. The stability of the slope against sliding is defined by the relationship between the shear forces and the resistance to shear. The main force responsible for mass wasting is gravity (UNESCO/UNEP, 1988). The slope of Gimbi town is fall in to four categories. The minimum slope is observed is 0 and maximum slope is 38 and the average slope of the town is 11. The detail is presented as shown in figure-3.

- ✓ **Very gentle slope (0-15°):** this category covered more than 70% of the Gimbi town and only two landslides sites were identified on this slope.
- ✓ **Gentle slope (15-25°):** this category covered about 20% of the Gimbi town and only 17 landslides site were identified on this slope.
- ✓ **Moderately steep (25-35°) and steep (35-38°):** this category covered about 5% of the Gimbi town and only no landslide sites were identified on this slope.

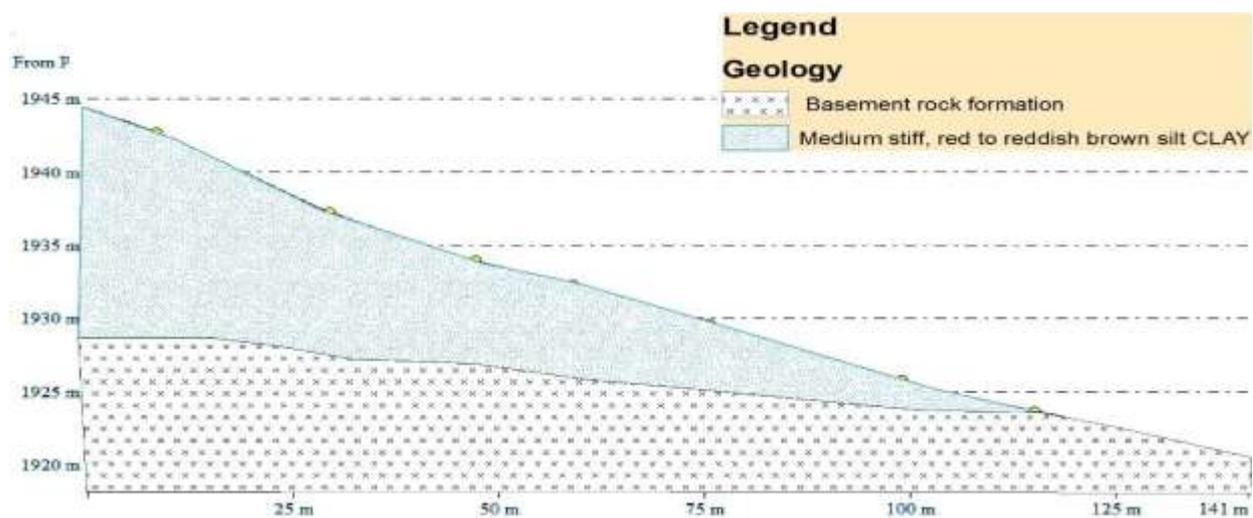
Figure-4: Geological section from fall existing retaining well to downstream

The geology of the site is characterized by overburden residual sediment and basement rock formation. **Overburden Residual sediment:** this sediment is characterized by reddish, silty clay soil, moist, not compacted, and firm. The thickness of the sediment is about 3-10 m. Construction Design SCO excavated the test pit. and the test pit depth is up to 2 m. This sediment is eroded at the bank of the river due to there is no outfall structure and the reset the sediment slide towards the river. **Basement rock:** the basement rock were exposed at the river bed and it is found below the sediment layer. The rock is very massive, moderately weathered, hard and impermeable rock formation.

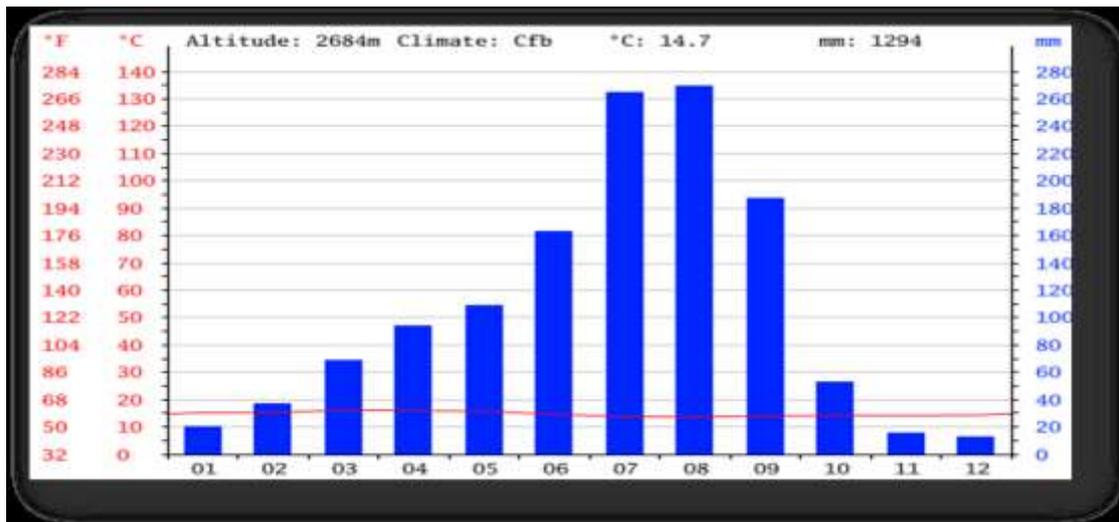
Figure-5 Rainfall Distribution of Study area

The Ethiopian highland is characterized by variable climatic conditions. The fact that the region is located in the tropics combined with the existing high range of altitude and air pressure difference determines the variation in climate that prevails in different areas (Chernet, 1993). Atmospheric temperature, of the highlands, varies from about 30<sup>0</sup> C to 50 C during the seasons October to January. According to the National Atlas of Ethiopia (1981), climatic conditions in the equatorial regions are strongly influenced by their altitude. The Gimbi town is lies in semi- temperate 1500- 2300 mean sea level with annual mean temperature of 15 to 20° C. The climate in Gimbi is warm and temperate. Gimbi is a city with a significant rainfall. Even in the driest month, there is a lot of rain. The average annual temperature is 14.7 °C in Gimbi. The driest month is December, with 13 mm of rain. Most of the precipitation here falls in August; averaging 269 mm. March is the warmest month of the year. The temperature in March averages 16.1 °C. August is the coldest month, with temperatures averaging 13.6 °C in table -2 given below.

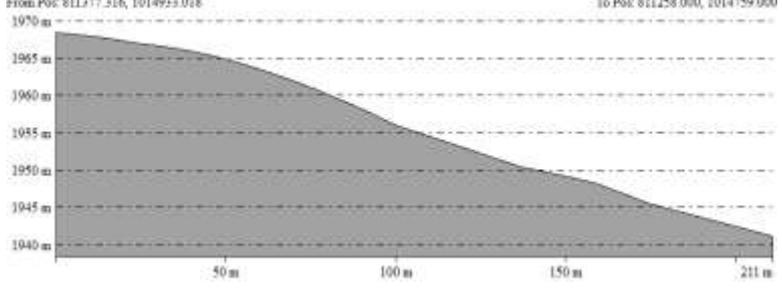
| Site Identification | Local Name | Date | Problem | Geographic coordinate (GPS) | | |
|---|---|---|---|---|---|---|
| 2 | Geomorphology | Average slope from top of catchment to affected area is 24% and it is very steep slope<br>From Pos: 811377.316, 1014933.018 To Pos: 811258.000, 1014759.000<br> | | | | |

The major trigger factor as per field observation is lack of proper outfall structure and scouring protection as per field observation. The overburden soil is silt clay soil and it is easily erodible material.

The land degradation is mainly due to drainage problem and it score the foot of the overburden soil. The soil degradation is inclined moment and it is categorized as landslide type of land degradation (figure below).

During field observation we observed the land slide is affect destroy homes, retaining well structure and road. Moreover, it is affect another area 100 m away from retain wall in downstream. The total estimated affected area is about 700 m<sup>2</sup>.

- Culver and Retaining well should be constructed at the bank of the river.
- The river channel bed should be protected from flood erosion with the use of appropriate structure, which extends at least 200 m from the culver to protect.
- Proper drainage channel should constructed upstream of culver site
- All the retaining well and structure foundation should be basement rock formation and its bearing capacity is about 3M Pa.

- Construction of Drainage Box Culverts
- Construction & Maintenance of Road with Masonry retaining structures
- Construction of Dwarf Concrete retaining Wall
- Construction Short Concrete wall along the river bank
- River train by gabion
